PRASA PROJECT

SELF INSPECTION SHEET

TUE	CAR	OPERATOR NAME	DATE	SELF INSPECTION NUMBER	PAGES
TS 230	TC2		19/06/24	**SI.FT1140.52**	01/08

TRAIN SET 230	REF: GIB0000001672_J0 PRASA WEIGHT BALANCE EN
	PC09 WEIGHING REPORT

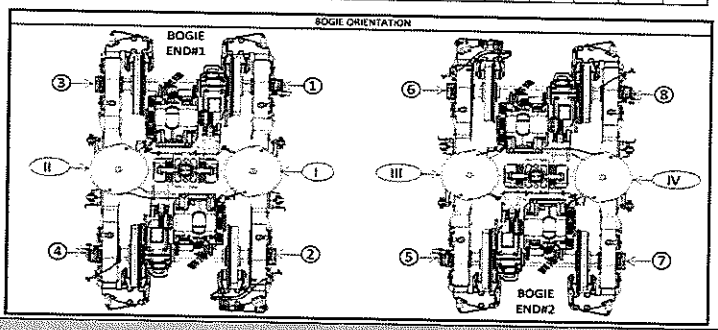
Weighting report from Test and Commissioning (Final measurements after Levelling and Weighting fine)
